Inspection Report

94 Dole Ave
Crystal Lake IL 60014

Healthy Home Mold Inspection

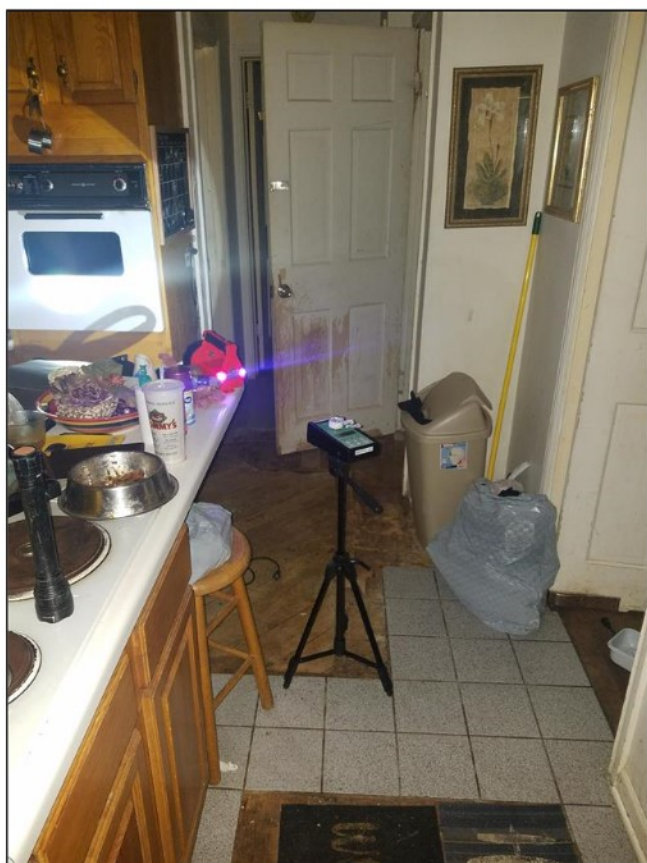
1.0 Item 1(Picture) Kitchen

(1) **Kitchen-** The air quality sample came back with elevated levels of **Penicillium/Aspergillus**.

Humidity levels are high at 62.8 relative humidity. RH levels should stay between 30%-55%

800 spores/m3 or more of **Penicillium/Aspergillus** is considered elevated.

2230 spores/m3 of **Penicillium/Aspergillus** was detected in kitchen.

Based on mold test results and visual inspection, it is my professional opinion that a qualified remediation company be contracted to perform a mold remediation at the property in question. Anyone entering the property needs to wear masks and not touch moldy materials without wearing gloves.

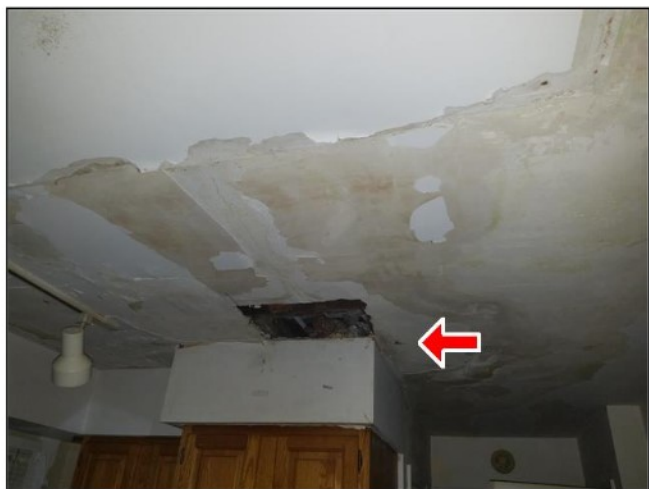
1.0 Item 2(Picture) Kitchen ceiling

(2) Kitchen ceiling has had multiple water intrusions and repairs. Visual mold growth was detected on the drywall.

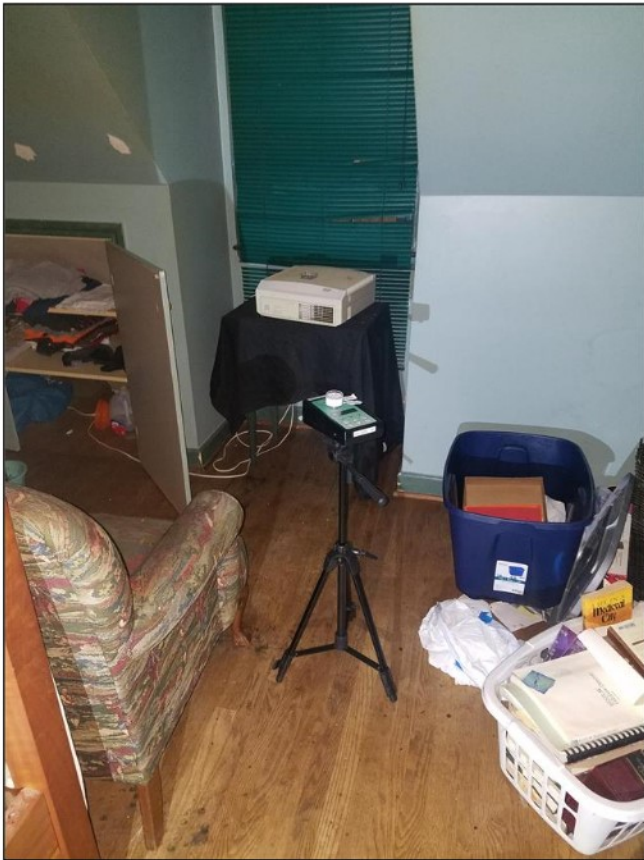
1.1 Item 1(Picture) Master bedroom

(1) **Master bedroom-** The air quality sample came back with elevated levels of **Penicillium/Aspergillus**.

800 spores/m³ or more of **Penicillium/Aspergillus** is considered elevated.

1810 spores/m³ of **Penicillium/Aspergillus** was detected in master bedroom.

Based on mold test results and visual inspection, it is my professional opinion that a qualified remediation company be contracted to perform a mold remediation at the property in question. Anyone entering the property needs to wear masks and not touch moldy materials without wearing gloves.

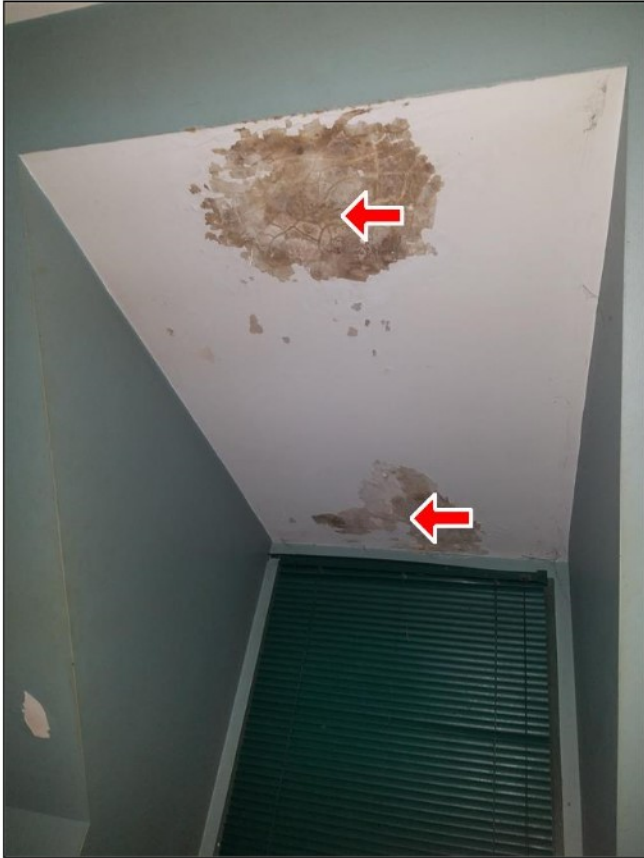
1.1 Item 2(Picture) Master bedroom drywall

(2) Master bedroom drywall- The area in question was tested with a moisture meter resulting high levels of moisture. The drywall is saturated due to a water damage from a leak.

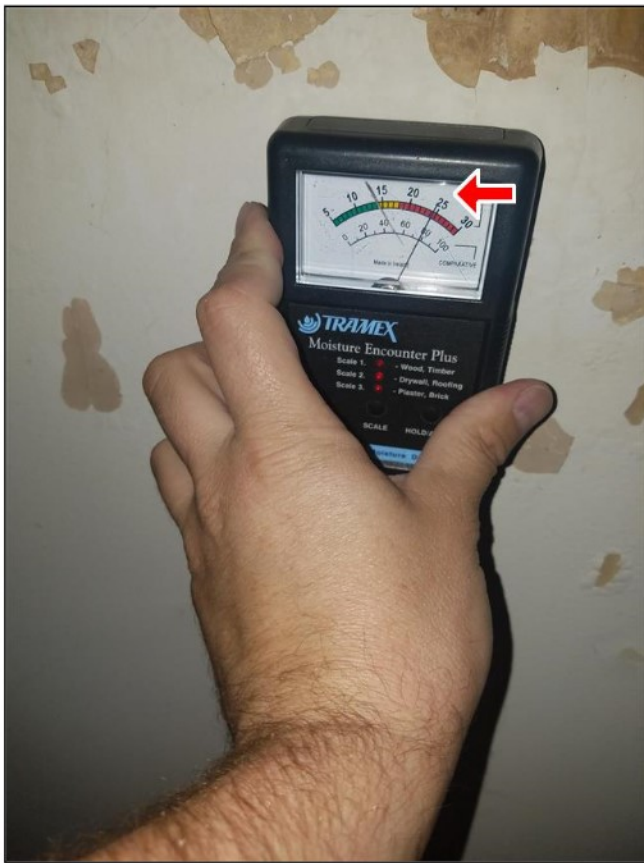
1.1 Item 3(Picture) Master bedroom drywall

(3) Additional picture of moisture readings of master bedroom drywall.

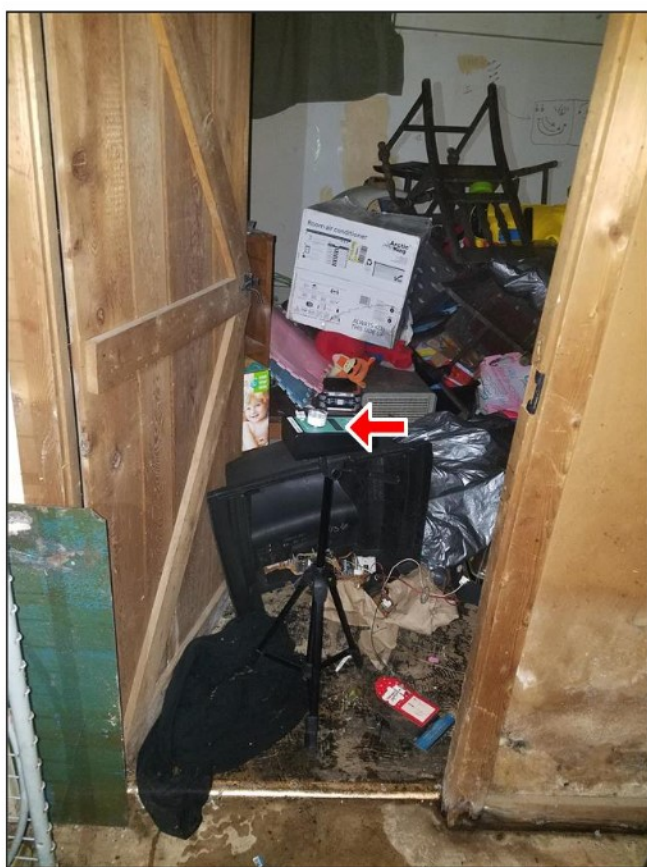
1.2 Item 1(Picture) Basement

(1) **Basement**- The air quality came back with elevated levels of **Penicillium/Aspergillus**, **Stachybotrys (black mold)**, and **Chaetomium**. Humidity levels are high at 75.1 relative humidity. RH levels should stay between 30%-55%

800 spores/m3 or more of **Penicillium/Aspergillus** is considered elevated.

17200 spores/m3 of **Penicillium/Aspergillus** was detected in basement.

5 raw spores or more of **Stachybotrys or Chaetomium** is considered elevated.

57 raw spores of **Chaetomium** was detected in basement.

72 raw spores of **Stachybotrys** was detected in basement.

Based on mold test results and visual inspection, it is my professional opinion that a qualified remediation company be contracted to perform a mold remediation at the property in question. Anyone entering the property needs to wear masks and not touch moldy materials without wearing gloves.

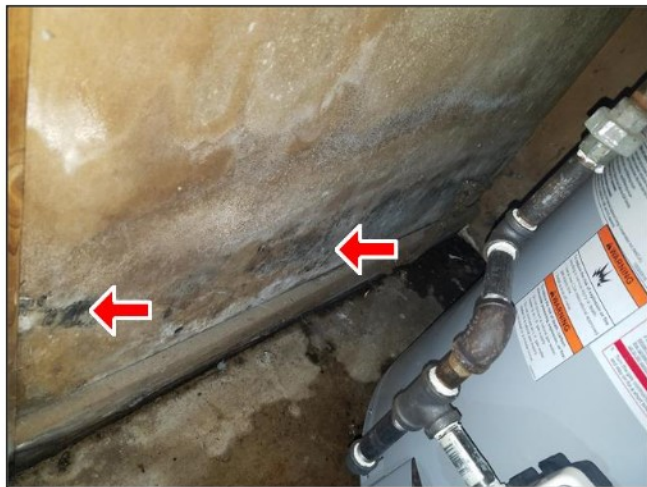
1.2 Item 2(Picture) Basement drywall

(2) **Basement drywall-** The surface sample came back with elevated levels of **Penicillium/Aspergillus & Stachybotrys**.

Standing water was detected in the basement. Multiple areas of visual mold growth was detected on items throughout the basement. Visual growth was also detected on the basement ceiling joists.

Based on mold test results and visual inspection, it is my professional opinion that a qualified remediation company be contracted to perform a mold remediation at the property in question
